**Preservation Management Plan
for the
Elm Street Cemetery
Braintree, Massachusetts
Volume II: Treatment Proposals**

Prepared for:
The City of Braintree
Braintree, Massachusetts
February, 2011

VOLUME II – TREATMENT PROPOSALS

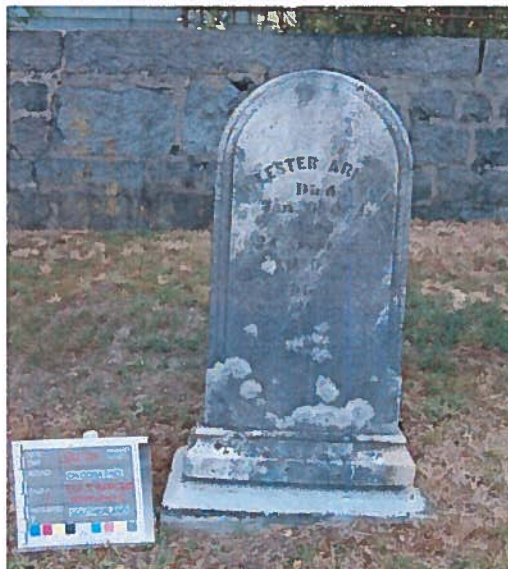
Existing Condition

Position: ☐ fallen ☒ tilted ☐ unstable ☐ unattached/loose ☐ missing

Legibility: ☐ sharp, tooling evident ☒ clear, but worn ☐ partially discernable ☐ not discernable

Deterioration: ☐ broken ☐ cracked ☐ losses ☐ flaking/sugaring ☒ ferrous pins ☐ brass pins
☐ delamination/detachment ☐ spalling ☐ missing fragments ☐ other:

Soiling: ☒ biological ☐ staining ☐ efflorescence ☐ other:

Position: ☒ reset/level in ground ☒ reset/level to existing base ☐ construct new base ☐ resquare
☐ possible new base required ☐ stabilize foundation ☐ reset with NHL 3.5 1:2.5 mix ☐ reset with compound

Treatment: ☒ core drill ☒ drill and pin ☐ simple adhesive repair ☐ injection grout ☐ replace bricks
☐ infill losses ☐ repoint ☐ other:

Cost: \$900

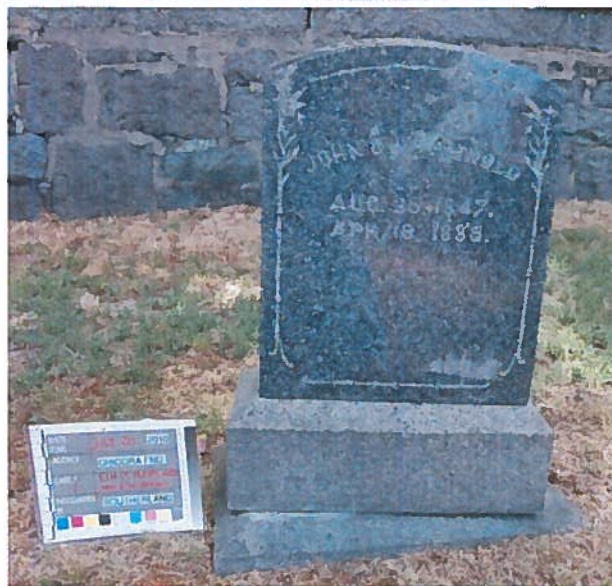
Existing Condition

Position: ☐ fallen ☐ tilted ☐ unstable ☒ unattached/loose ☐ missing

Legibility: ☒ sharp, tooling evident ☐ clear, but worn ☐ partially discernable ☐ not discernable

Deterioration: ☐ broken ☐ cracked ☐ losses ☐ flaking/sugaring ☐ ferrous pins ☐ brass pins
☐ delamination/detachment ☐ spalling ☐ missing fragments ☐ other:

Position: ☐ reset/level in ground ☒ reset/level to existing base ☐ construct new base ☐ resquare
☐ possible new base required ☐ stabilize foundation ☐ reset with NHL 3.5 1:2.5 mix ☒ reset with compound

Treatment: ☐ core drill ☒ drill and pin ☐ simple adhesive repair ☐ injection grout ☐ replace bricks
☐ infill losses ☐ repoint ☐ other:

Cost: \$700

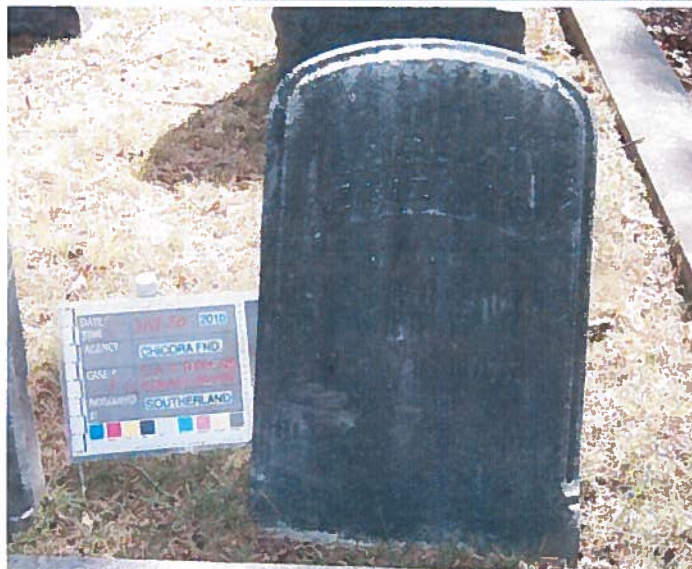
Existing Condition

Position: ☐ fallen ☒ tilted ☐ unstable ☐ unattached/loose ☐ missing

Legibility: ☐ sharp, tooling evident ☐ clear, but worn ☒ partially discernable ☐ not discernable

Deterioration: ☐ broken ☐ cracked ☐ losses ☐ flaking/sugaring ☐ ferrous pins ☐ brass pins
☐ delamination/detachment ☐ spalling ☐ missing fragments ☒ other: weathering

Soiling: ☒ biological ☒ staining ☐ efflorescence ☐ other:

Position: ☒ reset/level in ground ☐ reset/level to existing base ☐ construct new base ☐ resquare
☐ possible new base required ☐ stabilize foundation ☐ reset with NHL 3.5 1:2.5 mix ☐ reset with compound

Treatment: ☐ core drill ☐ drill and pin ☐ simple adhesive repair ☐ injection grout ☐ replace bricks
☐ infill losses ☐ repaint ☒ other: evaluate base if present

Cost: \$200

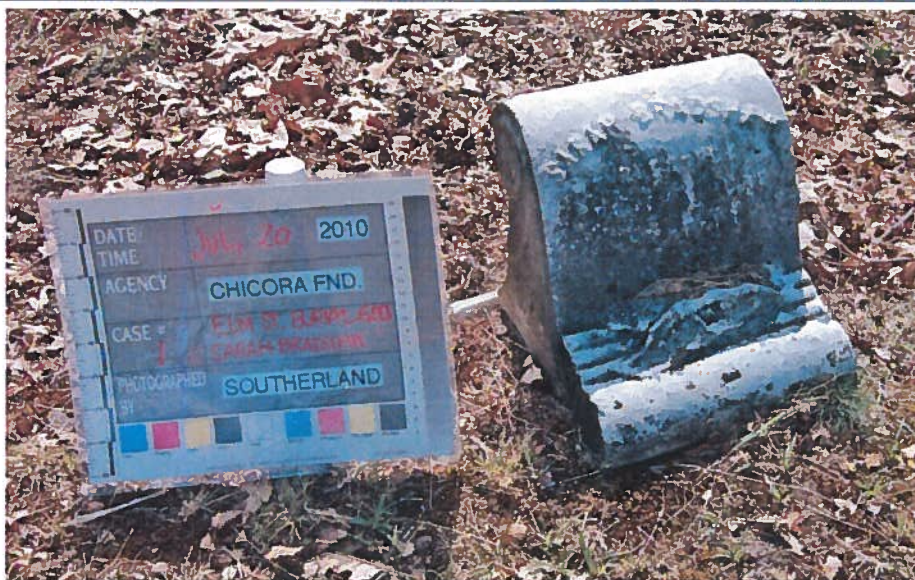
Position: ☐ fallen ☐ tilted ☐ unstable ☐ unattached/loose ☐ missing

Legibility: ☐ sharp, tooling evident ☐ clear, but worn ☒ partially discernable ☐ not discernable

Deterioration: ☐ broken ☐ cracked ☐ losses ☐ flaking/sugaring ☐ ferrous pins ☐ brass pins
☐ delamination/detachment ☐ spalling ☐ missing fragments ☒ other: severe weathering

Soiling: ☒ biological ☒ staining ☐ efflorescence ☐ other:

Treatment: ☐ core drill ☐ drill and pin ☐ simple adhesive repair ☐ injection grout ☐ replace bricks
☐ infill losses ☐ repoint ☒ other: consolidate with HCT

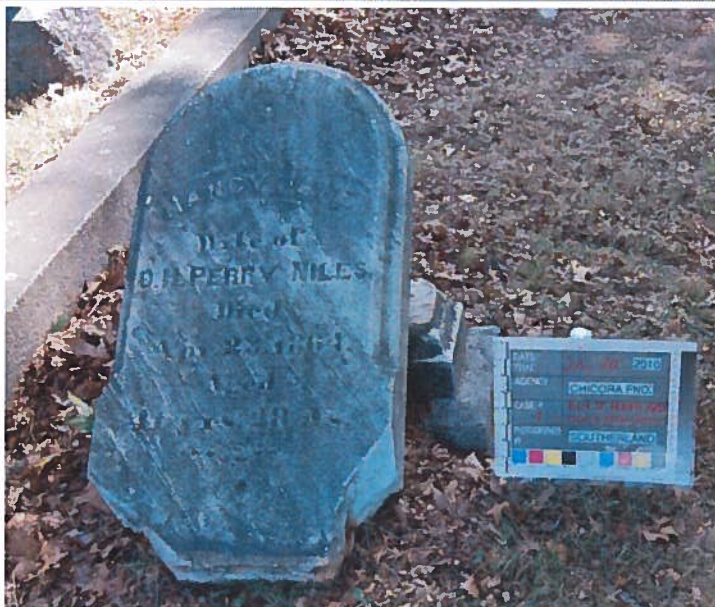
Existing Condition

Position: ☒ fallen ☐ tilted ☐ unstable ☐ unattached/loose ☐ missing

Legibility: ☐ sharp, tooling evident ☒ clear, but worn ☐ partially discernable ☐ not discernable

Deterioration: ☒ broken ☐ cracked ☐ losses ☐ flaking/sugaring ☒ ferrous pins ☐ brass pins
☐ delamination/detachment ☒ spalling ☐ missing fragments ☒ other: weathering

Soiling: ☒ biological ☒ staining ☐ efflorescence ☐ other:

Position: ☒ reset/level in ground ☒ reset/level to existing base ☐ construct new base ☐ resquare
☐ possible new base required ☐ stabilize foundation ☒ reset with NHL 3.5 1:2.5 mix ☐ reset with compound

Treatment: ☐ core drill ☒ drill and pin ☐ simple adhesive repair ☐ injection grout ☐ replace bricks
☒ infill losses ☐ repoint ☒ other: consolidate with HCT

Cost: \$1100

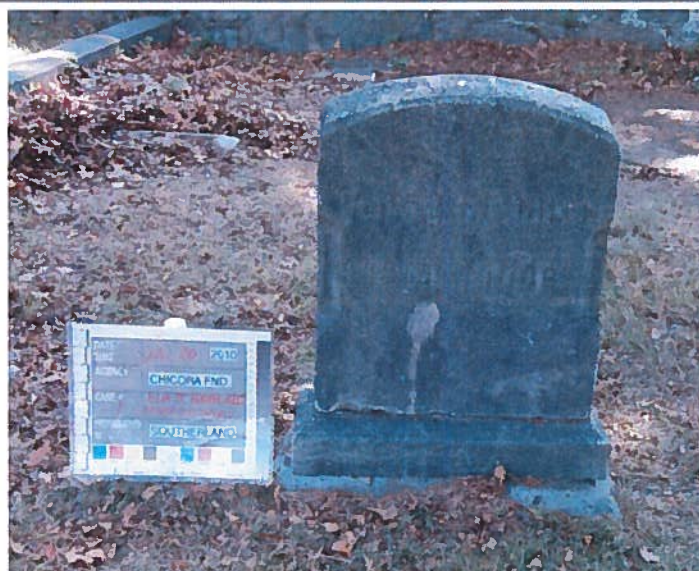
Existing Condition

Position: ☐ fallen ☐ tilted ☒ unstable ☐ unattached/loose ☐ missing

Legibility: ☐ sharp, tooling evident ☒ clear, but worn ☐ partially discernable ☐ not discernable

Deterioration: ☐ broken ☐ cracked ☐ losses ☐ flaking/sugaring ☐ ferrous pins ☐ brass pins
☐ delamination/detachment ☐ spalling ☐ missing fragments ☒ other: no pins

Soiling: ☒ biological ☒ staining ☐ efflorescence ☒ other: urine stain

Position: ☒ reset/level in ground ☒ reset/level to existing base ☐ construct new base ☐ resquare
☐ possible new base required ☐ stabilize foundation ☒ reset with NHL 3.5 1:2.5 mix ☐ reset with compound

Treatment: ☐ core drill ☒ drill and pin ☐ simple adhesive repair ☐ injection grout ☐ replace bricks
☐ infill losses ☐ repoint ☐ other:

Cost: \$600

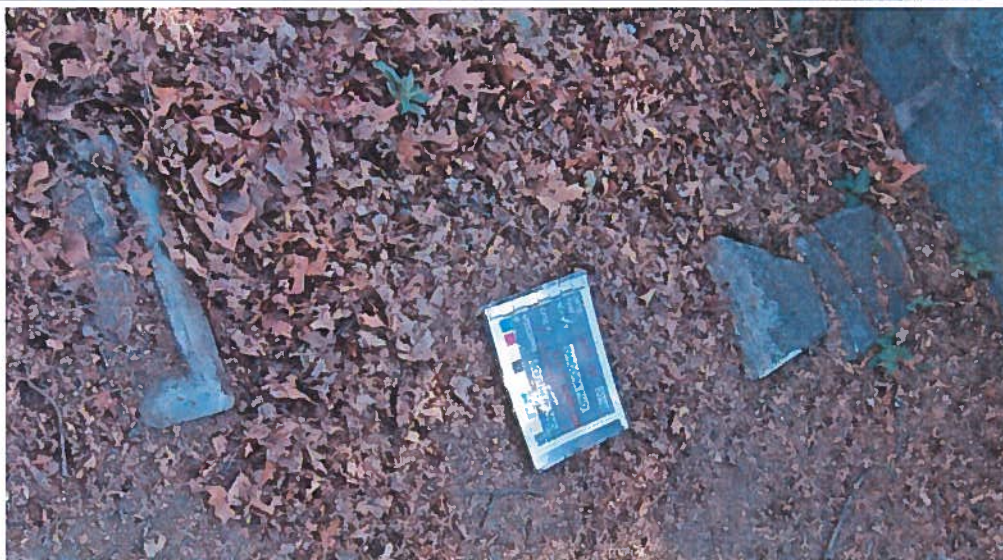
Existing Condition

Position: ☒ fallen ☐ tilted ☐ unstable ☐ unattached/loose ☐ missing

Legibility: ☐ sharp, tooling evident ☒ clear, but worn ☐ partially discernable ☐ not discernable

Deterioration: ☒ broken ☐ cracked ☐ losses ☐ flaking/sugaring ☐ ferrous pins ☐ brass pins
☐ delamination/detachment ☐ spalling ☐ missing fragments ☒ other: base in 2 pieces; stone in 5; missing fragments

Soiling: ☒ biological ☒ staining ☐ efflorescence ☐ other:

Position: ☒ reset/level in ground ☒ reset/level to existing base ☐ construct new base ☐ resquare
☐ possible new base required ☐ stabilize foundation ☐ reset with NHL 3.5 1:2.5 mix ☐ reset with compound

Treatment: ☐ core drill ☒ drill and pin ☐ simple adhesive repair ☐ injection grout ☐ replace bricks
☒ infill losses ☐ repoint ☐ other:

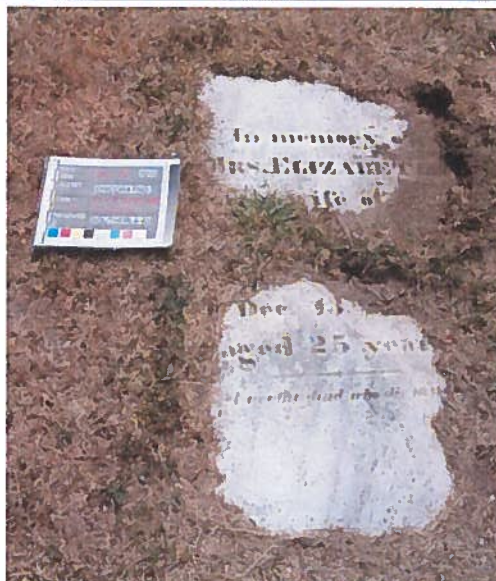
Elm Street Cemetery, Braintree, MA
Monument Treatment Proposal

Existing Condition

Position: ☒ fallen ☒ tilted ☐ unstable ☐ unattached/loose ☐ missing

Legibility: ☐ sharp, tooling evident ☒ clear, but worn ☐ partially discernable ☐ not discernable

Deterioration: ☒ broken ☐ cracked ☐ losses ☐ flaking/sugaring ☐ ferrous pins ☐ brass pins
☐ delamination/detachment ☐ spalling ☐ missing fragments ☐ other:

Failed/Old Treatments: ☐ metal ☒ adhesives/coatings ☐ mortar ☐ other:

Soiling: ☒ biological ☐ staining ☐ efflorescence ☐ other:

Position: ☒ reset/level in ground ☐ reset/level to existing base ☐ construct new base ☐ resquare
☐ possible new base required ☐ stabilize foundation ☐ reset with NHL 3.5 1:2.5 mix ☐ reset with compound

Failed Treatments: ☐ drill/grind ☒ hand tools ☐ solvents ☐ other:

Treatment: ☐ core drill ☒ drill and pin ☐ simple adhesive repair ☐ injection grout ☐ replace bricks
☒ infill losses ☐ repoint ☒ other: consolidate with HCT

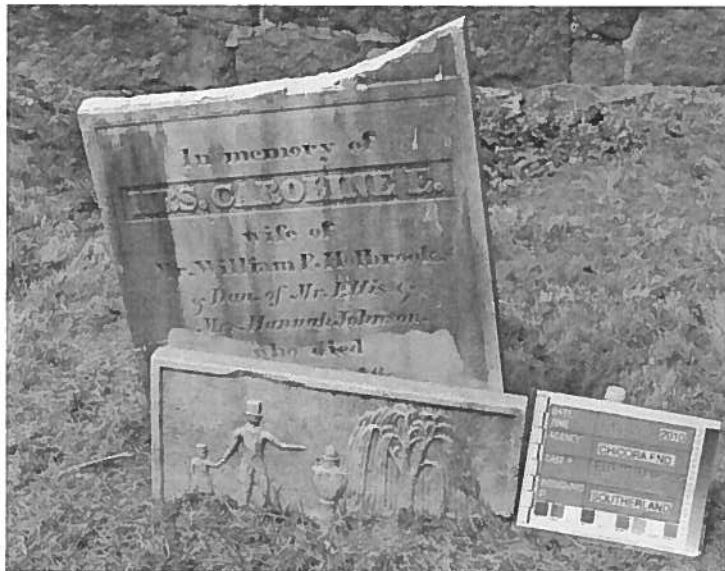
Elm Street Cemetery, Braintree, MA
Monument Treatment Proposal

Existing Condition

Position: ☐ fallen ☒ tilted ☒ unstable ☐ unattached/loose ☐ missing

Legibility: ☐ sharp, tooling evident ☒ clear, but worn ☐ partially discernable ☐ not discernable

Deterioration: ☐ broken ☒ cracked ☐ losses ☐ flaking/sugaring ☒ ferrous pins ☐ brass pins
☐ delamination/detachment ☐ spalling ☐ missing fragments ☒ other: finial upside down

Failed/Old Treatments: ☐ metal ☒ adhesives/coatings ☐ mortar ☐ other:

Soiling: ☒ biological ☐ staining ☐ efflorescence ☐ other:

Position: ☒ reset/level in ground ☐ reset/level to existing base ☐ construct new base ☐ resquare
☐ possible new base required ☐ stabilize foundation ☐ reset with NHL 3.5 1:2.5 mix ☐ reset with compound

Failed Treatments: ☐ drill/grind ☒ hand tools ☐ solvents ☒ other: finial attached with adhesive

Treatment: ☒ core drill ☒ drill and pin ☐ simple adhesive repair ☐ injection grout ☐ replace bricks
☒ infill losses ☐ repoint ☐ other:

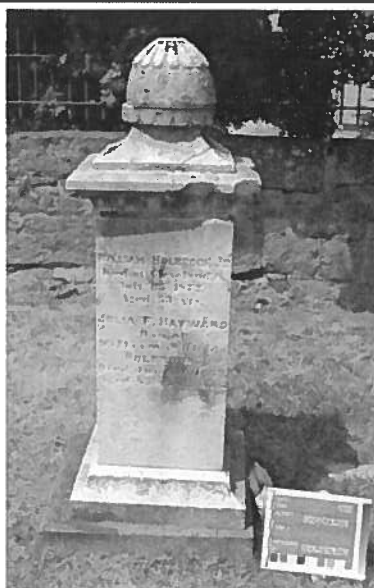
Elm Street Cemetery, Braintree, MA
Monument Treatment Proposal

Existing Condition

Position: ☒ fallen ☐ tilted ☐ unstable ☐ unattached/loose ☐ missing

Legibility: ☐ sharp, tooling evident ☒ clear, but worn ☐ partially discernable ☐ not discernable

Deterioration: ☒ broken ☐ cracked ☐ losses ☐ flaking/sugaring ☐ ferrous pins ☐ brass pins
☐ delamination/detachment ☐ spalling ☐ missing fragments ☒ other: weathered

Failed/Old Treatments: ☐ metal ☐ adhesives/coatings ☐ mortar ☐ other:

Soiling: ☒ biological ☐ staining ☐ efflorescence ☐ other:

Position: ☒ reset/level in ground ☐ reset/level to existing base ☐ construct new base ☐ resquare
☐ possible new base required ☐ stabilize foundation ☐ reset with NHL 3.5 1:2.5 mix ☐ reset with compound

Failed Treatments: ☐ drill/grind ☐ hand tools ☐ solvents ☐ other:

Treatment: ☐ core drill ☒ drill and pin ☐ simple adhesive repair ☐ injection grout ☐ replace bricks
☒ infill losses ☐ repoint ☒ other: consolidate HCT

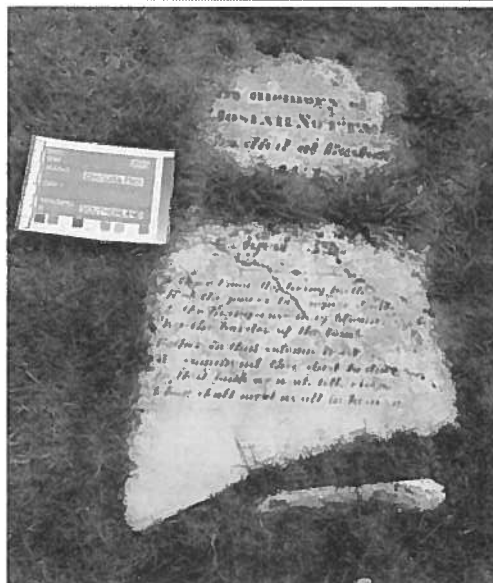
Elm Street Cemetery, Braintree, MA
Monument Treatment Proposal

Existing Condition

Position: ☐ fallen ☒ tilted ☐ unstable ☐ unattached/loose ☐ missing

Legibility: ☐ sharp, tooling evident ☒ clear, but worn ☐ partially discernable ☐ not discernable

Deterioration: ☐ broken ☐ cracked ☐ losses ☐ flaking/sugaring ☐ ferrous pins ☐ brass pins
☐ delamination/detachment ☐ spalling ☐ missing fragments ☐ other:

Failed/Old Treatments: ☐ metal ☐ adhesives/coatings ☐ mortar ☐ other:

Soiling: ☒ biological ☐ staining ☐ efflorescence ☐ other:

Position: ☒ reset/level in ground ☐ reset/level to existing base ☐ construct new base ☐ resquare
☐ possible new base required ☐ stabilize foundation ☐ reset with NHL 3.5 1:2.5 mix ☐ reset with compound

Failed Treatments: ☐ drill/grind ☐ hand tools ☐ solvents ☐ other:

Treatment: ☐ core drill ☐ drill and pin ☐ simple adhesive repair ☐ injection grout ☐ replace bricks
☐ infill losses ☐ repoint ☒ other: additional damage may be found as stone is being reset

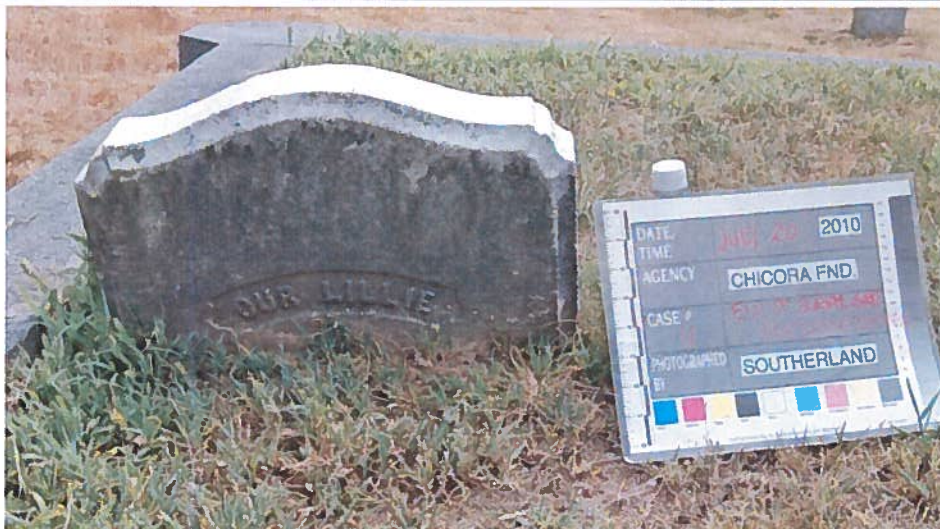
Elm Street Cemetery, Braintree, MA
Monument Treatment Proposal

Existing Condition

Position: ☐ fallen ☒ tilted ☒ unstable ☐ unattached/loose ☐ missing

Legibility: ☒ sharp, tooling evident ☐ clear, but worn ☐ partially discernable ☐ not discernable

Deterioration: ☐ broken ☐ cracked ☐ losses ☐ flaking/sugaring ☐ ferrous pins ☐ brass pins
☐ delamination/detachment ☐ spalling ☐ missing fragments ☐ other:

Failed/Old Treatments: ☐ metal ☐ adhesives/coatings ☐ mortar ☐ other:

Soiling: ☐ biological ☐ staining ☐ efflorescence ☐ other:

Position: ☒ reset/level in ground ☐ reset/level to existing base ☐ construct new base ☐ resquare
☐ possible new base required ☐ stabilize foundation ☐ reset with NHL 3.5 1:2.5 mix ☐ reset with compound

Failed Treatments: ☐ drill/grind ☐ hand tools ☐ solvents ☐ other:

Treatment: ☐ core drill ☐ drill and pin ☐ simple adhesive repair ☐ injection grout ☐ replace bricks
☐ infill losses ☐ repoint ☒ other: remove dead plant material to allow steps to be reset and leveled

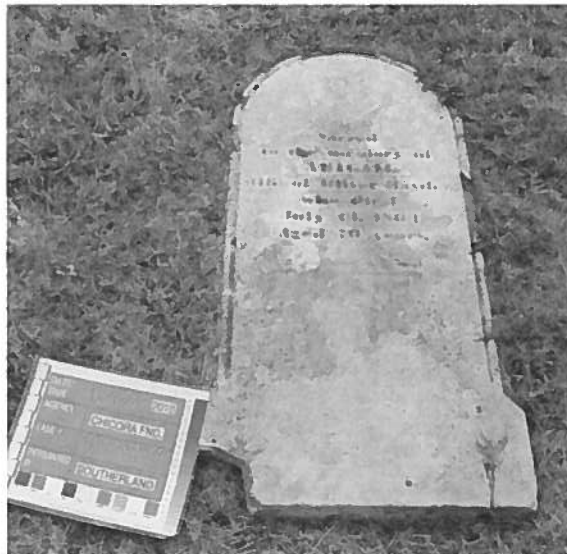
Elm Street Cemetery, Braintree, MA
Monument Treatment Proposal

Existing Condition

Position: ☐ fallen ☒ tilted ☐ unstable ☐ unattached/loose ☐ missing

Legibility: ☐ sharp, tooling evident ☒ clear, but worn ☐ partially discernable ☐ not discernable

Deterioration: ☐ broken ☐ cracked ☐ losses ☐ flaking/sugaring ☐ ferrous pins ☐ brass pins
☐ delamination/detachment ☐ spalling ☐ missing fragments ☒ other: base sunk; weathered

Failed/Old Treatments: ☐ metal ☐ adhesives/coatings ☐ mortar ☐ other:

Soiling: ☒ biological ☐ staining ☐ efflorescence ☐ other:

Position: ☒ reset/level in ground ☒ reset/level to existing base ☐ construct new base ☐ resquare
☐ possible new base required ☐ stabilize foundation ☒ reset with NHL 3.5 1:2.5 mix ☐ reset with compound

Failed Treatments: ☐ drill/grind ☐ hand tools ☐ solvents ☐ other:

Treatment: ☒ core drill ☐ drill and pin ☐ simple adhesive repair ☐ injection grout ☐ replace bricks
☐ infill losses ☐ repoint ☐ other:

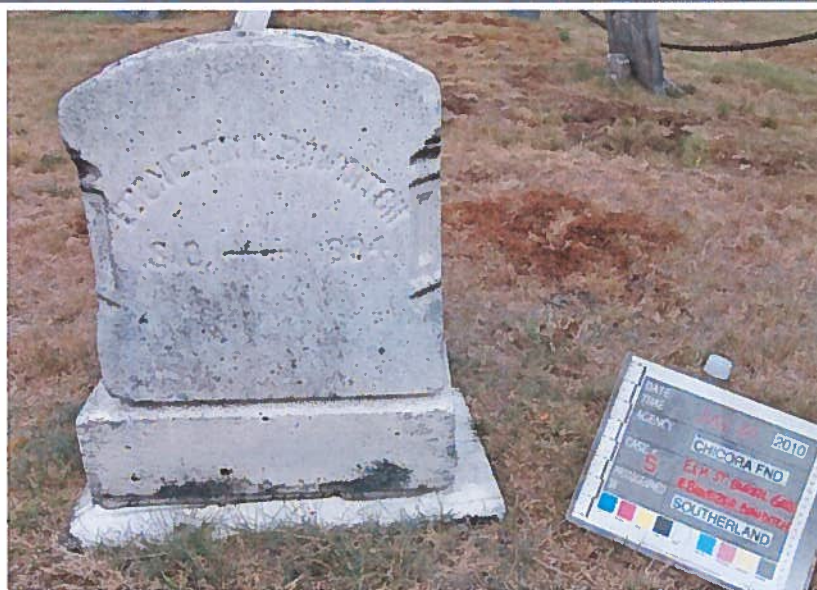
Section: 5

Position: ☐ fallen ☒ tilted ☐ unstable ☒ unattached/loose ☐ missing

Legibility: ☐ sharp, tooling evident ☒ clear, but worn ☐ partially discernable ☐ not discernable

Deterioration: ☐ broken ☐ cracked ☐ losses ☐ flaking/sugaring ☐ ferrous pins ☐ brass pins
☐ delamination/detachment ☐ spalling ☐ missing fragments ☐ other:

Soiling: ☒ biological ☐ staining ☐ efflorescence ☐ other:

Position: ☐ reset/level in ground ☐ reset/level to existing base ☐ construct new base ☐ resquare
☐ possible new base required ☐ stabilize foundation ☒ reset with NHL 3.5 1:2.5 mix ☐ reset with compound

Treatment: ☐ core drill ☒ drill and pin ☐ simple adhesive repair ☐ injection grout ☐ replace bricks
☐ infill losses ☐ repoint ☒ other: consolidate with HCT

Cost: \$900

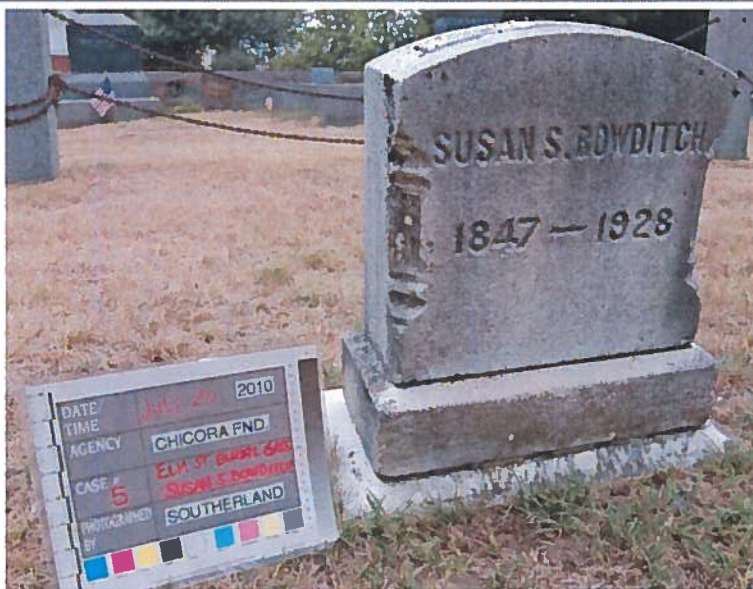
Section: 5

Position: ☐ fallen ☐ tilted ☒ unstable ☒ unattached/loose ☐ missing

Legibility: ☐ sharp, tooling evident ☒ clear, but worn ☐ partially discernable ☐ not discernable

Deterioration: ☐ broken ☐ cracked ☐ losses ☐ flaking/sugaring ☐ ferrous pins ☒ brass pins
☐ delamination/detachment ☐ spalling ☐ missing fragments ☒ other: weathered

Soiling: ☒ biological ☐ staining ☐ efflorescence ☐ other:

Position: ☐ reset/level in ground ☒ reset/level to existing base ☐ construct new base ☐ resquare
☐ possible new base required ☐ stabilize foundation ☒ reset with NHL 3.5 1:2.5 mix ☐ reset with compound

Treatment: ☐ core drill ☒ drill and pin ☐ simple adhesive repair ☐ injection grout ☐ replace bricks
☐ infill losses ☐ repoint ☒ other: replace brass pins with stainless steel; consolidate with HCT

Cost: \$900

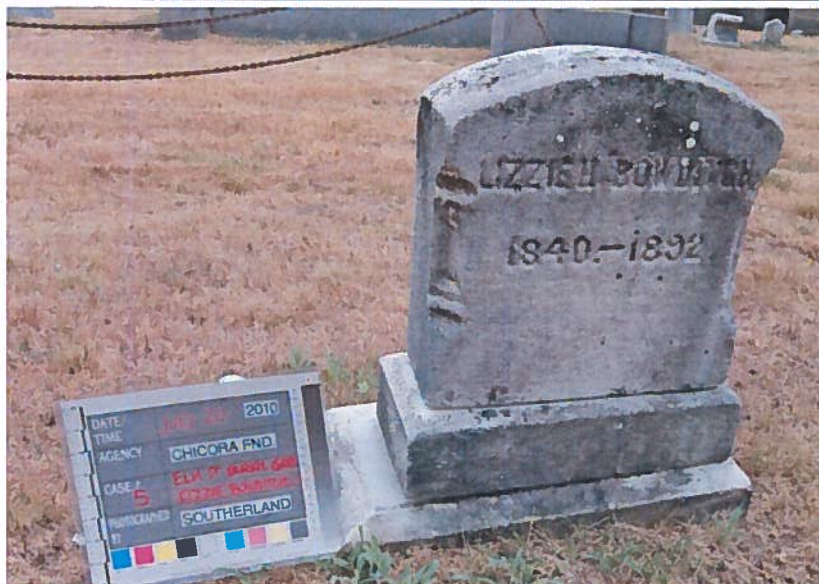
Section: 5

Position: ☐ fallen ☒ tilted ☒ unstable ☒ unattached/loose ☐ missing

Legibility: ☐ sharp, tooling evident ☐ clear, but worn ☒ partially discernable ☐ not discernable

Deterioration: ☐ broken ☐ cracked ☐ losses ☐ flaking/sugaring ☐ ferrous pins ☒ brass pins
☐ delamination/detachment ☐ spalling ☐ missing fragments ☒ other: weathered

Soiling: ☒ biological ☐ staining ☐ efflorescence ☐ other:

Position: ☐ reset/level in ground ☒ reset/level to existing base ☐ construct new base ☐ resquare
☐ possible new base required ☐ stabilize foundation ☒ reset with NHL 3.5 1:2.5 mix ☐ reset with compound

Treatment: ☐ core drill ☒ drill and pin ☐ simple adhesive repair ☐ injection grout ☐ replace bricks
☐ infill losses ☐ repoint ☒ other: replace brass pins with stainless steel; consolidate with HCT

Cost: \$900

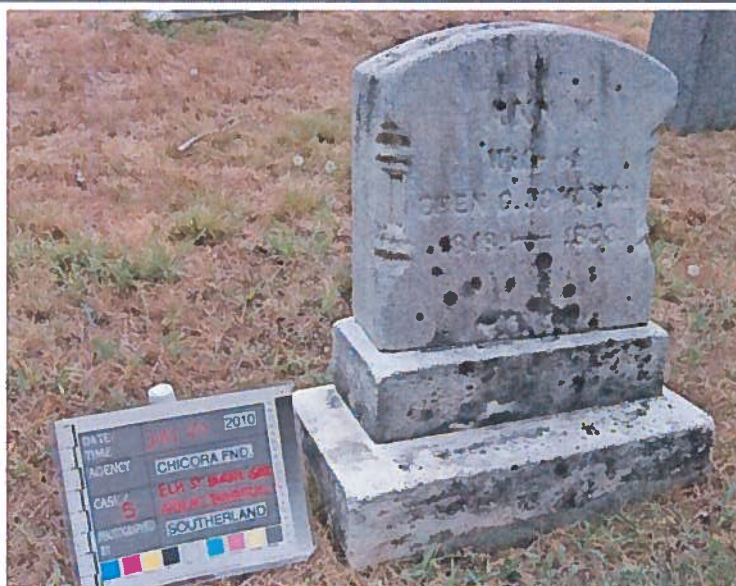
Section: 5

Position: ☐ fallen ☒ tilted ☒ unstable ☒ unattached/loose ☐ missing

Legibility: ☐ sharp, tooling evident ☐ clear, but worn ☒ partially discernable ☐ not discernable

Deterioration: ☐ broken ☐ cracked ☐ losses ☐ flaking/sugaring ☐ ferrous pins ☒ brass pins
☐ delamination/detachment ☐ spalling ☐ missing fragments ☒ other: weathered

Soiling: ☒ biological ☐ staining ☐ efflorescence ☐ other:

Position: ☐ reset/level in ground ☒ reset/level to existing base ☐ construct new base ☐ resquare
☐ possible new base required ☐ stabilize foundation ☒ reset with NHL 3.5 1:2.5 mix ☐ reset with compound

Treatment: ☐ core drill ☒ drill and pin ☐ simple adhesive repair ☐ injection grout ☐ replace bricks
☐ infill losses ☐ repoint ☒ other: replace brass pins with stainless steel; consolidate with HCT

Cost: \$900

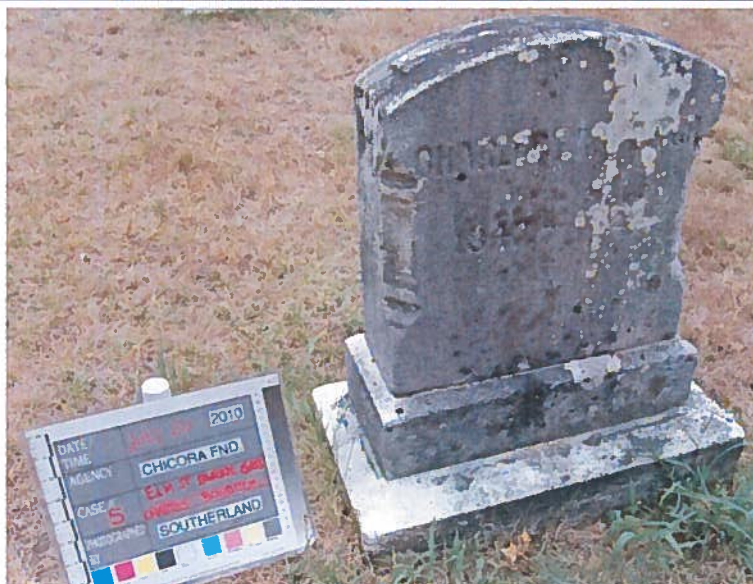
Section: 5

Position: ☐ fallen ☐ tilted ☐ unstable ☒ unattached/loose ☐ missing

Legibility: ☐ sharp, tooling evident ☒ clear, but worn ☐ partially discernable ☐ not discernable

Deterioration: ☒ broken ☐ cracked ☐ losses ☐ flaking/sugaring ☐ ferrous pins ☒ brass pins
☐ delamination/detachment ☐ spalling ☐ missing fragments ☐ other:

Soiling: ☒ biological ☐ staining ☐ efflorescence ☐ other:

Position: ☐ reset/level in ground ☒ reset/level to existing base ☐ construct new base ☐ resquare
☐ possible new base required ☐ stabilize foundation ☒ reset with NHL 3.5 1:2.5 mix ☐ reset with compound

Treatment: ☐ core drill ☒ drill and pin ☒ simple adhesive repair ☐ injection grout ☐ replace bricks
☒ infill losses ☐ repoint ☒ other: consolidate with HCT

Cost: \$1000

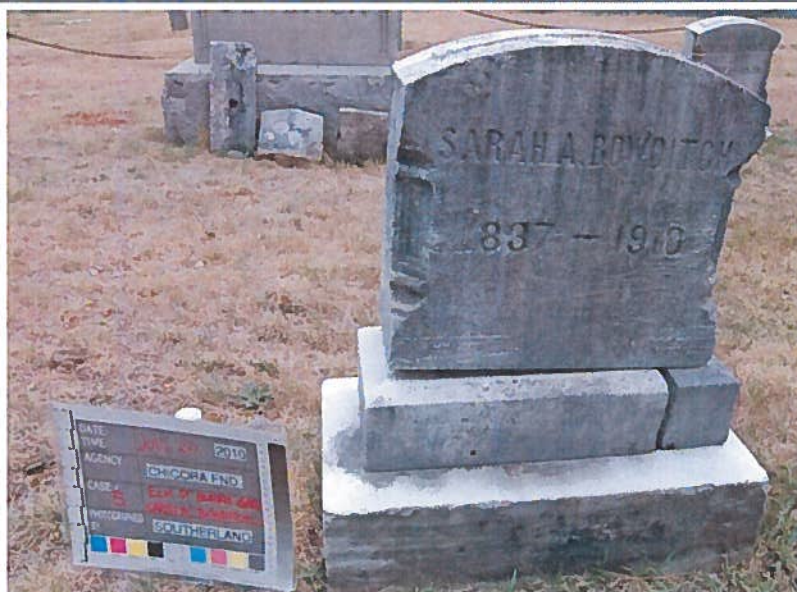
Section: 5

Position: ☐ fallen ☒ tilted ☒ unstable ☐ unattached/loose ☐ missing

Legibility: ☐ sharp, tooling evident ☒ clear, but worn ☐ partially discernable ☐ not discernable

Deterioration: ☐ broken ☐ cracked ☐ losses ☐ flaking/sugaring ☐ ferrous pins ☐ brass pins
☐ delamination/detachment ☐ spalling ☐ missing fragments ☐ other:

Soiling: ☒ biological ☐ staining ☐ efflorescence ☐ other:

Position: ☐ reset/level in ground ☐ reset/level to existing base ☐ construct new base ☐ resquare
☒ possible new base required ☐ stabilize foundation ☐ reset with NHL 3.5 1:2.5 mix ☐ reset with compound

Treatment: ☐ core drill ☒ drill and pin ☐ simple adhesive repair ☐ injection grout ☐ replace bricks
☒ infill losses ☐ repoint ☒ other: consolidate with HCT

Cost: \$1000

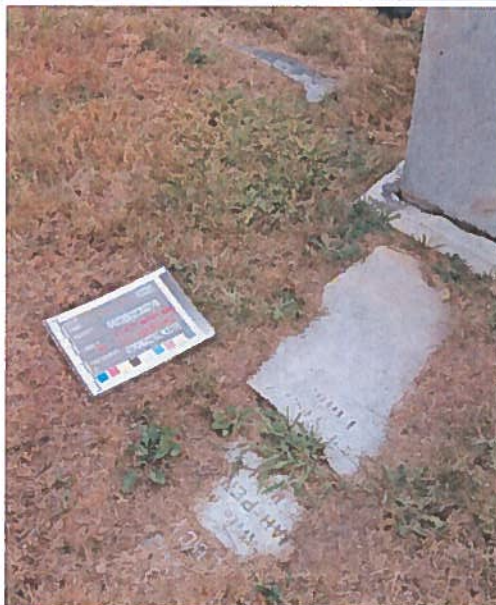
Section: 6

Existing Condition

Position: ☐ fallen ☒ tilted ☐ unstable ☐ unattached/loose ☐ missing

Legibility: ☒ sharp, tooling evident ☐ clear, but worn ☐ partially discernable ☐ not discernable

Deterioration: ☐ broken ☐ cracked ☐ losses ☐ flaking/sugaring ☐ ferrous pins ☐ brass pins
☐ delamination/detachment ☐ spalling ☐ missing fragments ☐ other:

Position: ☒ reset/level in ground ☐ reset/level to existing base ☐ construct new base ☐ resquare
☐ possible new base required ☐ stabilize foundation ☐ reset with NHL 3.5 1:2.5 mix ☐ reset with compound

Treatment: ☐ core drill ☐ drill and pin ☐ simple adhesive repair ☐ injection grout ☐ replace bricks
☐ infill losses ☐ repoint ☒ other: may also require pinning; check stability

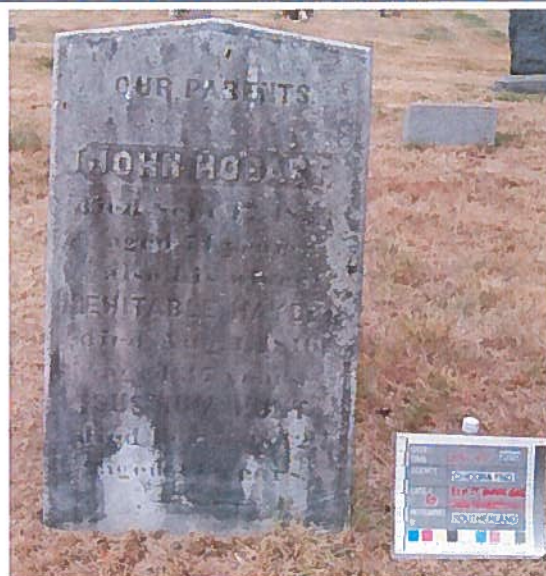
Section: 6

Position: ☐ fallen ☐ tilted ☐ unstable ☒ unattached/loose ☐ missing

Legibility: ☒ sharp, tooling evident ☐ clear, but worn ☐ partially discernable ☐ not discernable

Deterioration: ☐ broken ☐ cracked ☐ losses ☐ flaking/sugaring ☐ ferrous pins ☐ brass pins
☐ delamination/detachment ☐ spalling ☐ missing fragments ☒ other: corrosion

Position: ☐ reset/level in ground ☐ reset/level to existing base ☒ construct new base ☐ resquare
☐ possible new base required ☐ stabilize foundation ☐ reset with NHL 3.5 1:2.5 mix ☐ reset with compound

Treatment: ☐ core drill ☐ drill and pin ☐ simple adhesive repair ☐ injection grout ☐ replace bricks
☐ infill losses ☐ repoint ☒ other: paint with Rust Reformer; topcoat with alkyd flat black paint; pour 4" OPC base and mount door to base with 316 stainless steel clips; do not drill or otherwise damage door in mounting.

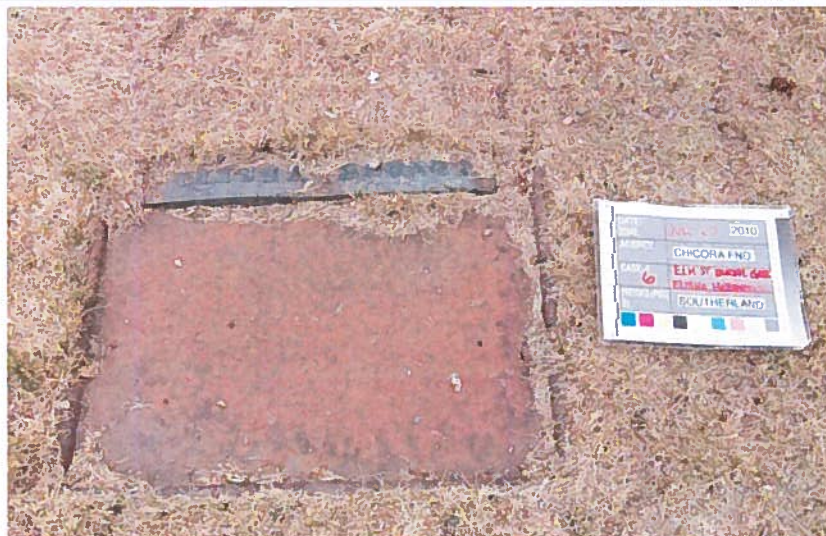
Section: 6

Existing Condition

Position: ☐ fallen ☐ tilted ☐ unstable ☒ unattached/loose ☐ missing

Legibility: ☒ sharp, tooling evident ☐ clear, but worn ☐ partially discernable ☐ not discernable

Deterioration: ☐ broken ☐ cracked ☐ losses ☐ flaking/sugaring ☐ ferrous pins ☐ brass pins
☐ delamination/detachment ☐ spalling ☐ missing fragments ☒ other: corrosion

Soiling: ☒ biological ☐ staining ☐ efflorescence ☐ other:

Position: ☐ reset/level in ground ☐ reset/level to existing base ☒ construct new base ☐ resquare
☐ possible new base required ☐ stabilize foundation ☐ reset with NHL 3.5 1:2.5 mix ☐ reset with compound

Treatment: ☐ core drill ☐ drill and pin ☐ simple adhesive repair ☐ injection grout ☐ replace bricks
☐ infill losses ☐ repoint ☒ other: paint with Rust Reformer; topcoat with alkyd flat black paint; pour 4" OPC base and mount door to base with 316 stainless steel clips; do not drill or otherwise damage door in mounting.

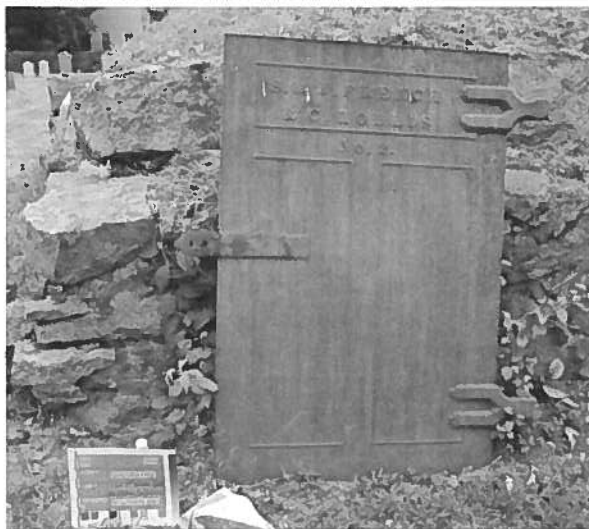
Section: B

Existing Condition

Deterioration: ☐ broken ☐ cracked ☐ losses ☐ flaking/sugaring ☐ ferrous pins ☐ brass pins
☐ delamination/detachment ☒ spalling ☐ missing fragments ☒ other: split

Soiling: ☒ biological ☐ staining ☐ efflorescence ☐ other:

Position: ☒ reset/level in ground ☐ reset/level to existing base ☐ construct new base ☐ resquare
☐ possible new base required ☐ stabilize foundation ☐ reset with NHL 3.5 1:2.5 mix ☐ reset with compound

Treatment: ☐ core drill ☐ drill and pin ☒ simple adhesive repair ☒ injection grout ☐ replace bricks
☒ infill losses ☐ repoint ☐ other:

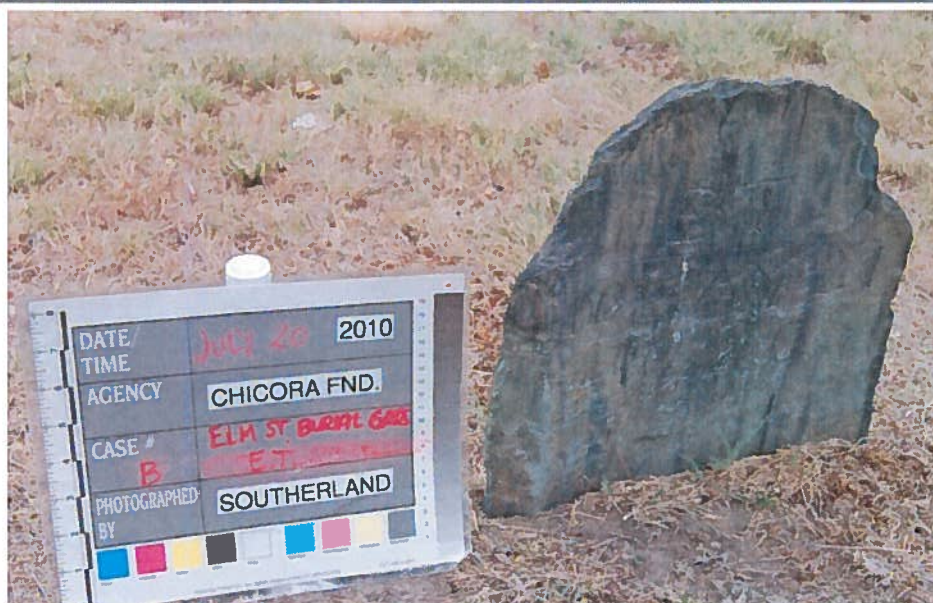
Section: B

Existing Condition

Position: ☐ fallen ☐ tilted ☐ unstable ☒ unattached/loose ☐ missing

Legibility: ☒ sharp, tooling evident ☐ clear, but worn ☐ partially discernable ☐ not discernable

Soiling: ☒ biological ☐ staining ☐ efflorescence ☐ other:

Position: ☒ reset/level in ground ☐ reset/level to existing base ☐ construct new base ☐ resquare
☐ possible new base required ☐ stabilize foundation ☐ reset with NHL 3.5 1:2.5 mix ☐ reset with compound

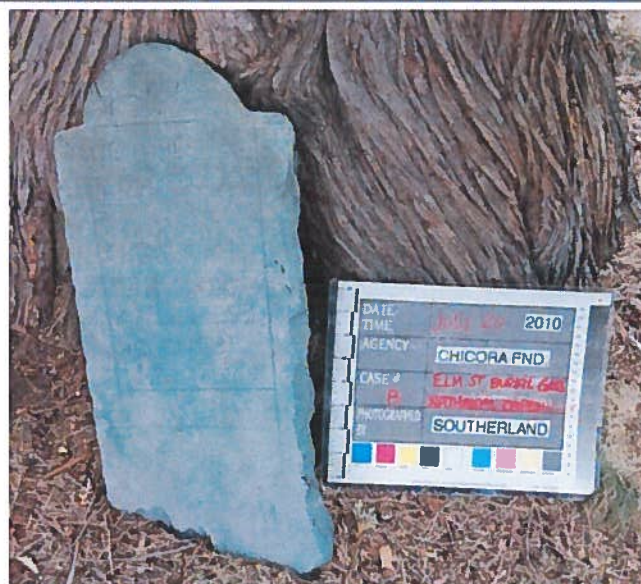
Section: B

Existing Condition

Legibility: ☒ sharp, tooling evident ☐ clear, but worn ☐ partially discernable ☐ not discernable

Deterioration: ☒ broken ☐ cracked ☐ losses ☐ flaking/sugaring ☐ ferrous pins ☐ brass pins
☐ delamination/detachment ☐ spalling ☐ missing fragments ☒ other: sunk into ground; mower damage

Soiling: ☒ biological ☐ staining ☐ efflorescence ☐ other:

Position: ☒ reset/level in ground ☐ reset/level to existing base ☐ construct new base ☐ resquare
☐ possible new base required ☐ stabilize foundation ☐ reset with NHL 3.5 1:2.5 mix ☐ reset with compound

Treatment: ☐ core drill ☐ drill and pin ☒ simple adhesive repair ☐ injection grout ☐ replace bricks
☒ infill losses ☐ repoint ☐ other:

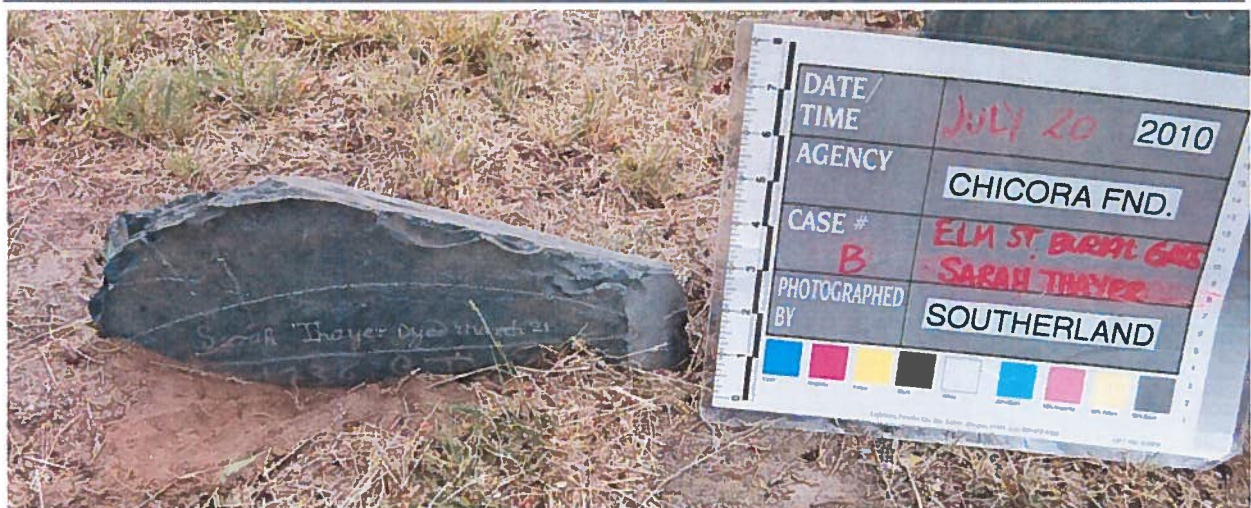
Section: B

Existing Condition

Deterioration: ☐ broken ☒ cracked ☐ losses ☐ flaking/sugaring ☐ ferrous pins ☐ brass pins
☐ delamination/detachment ☐ spalling ☐ missing fragments ☒ other: chipped; mower damage

Soiling: ☒ biological ☐ staining ☐ efflorescence ☐ other:

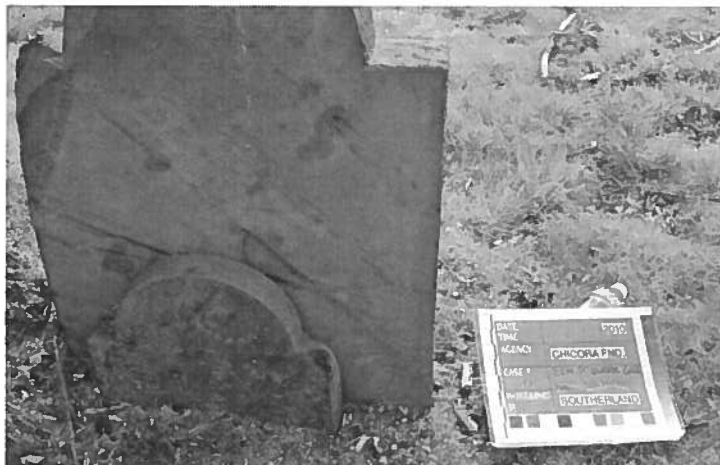
Section: D

Position: ☐ fallen ☐ tilted ☐ unstable ☐ unattached/loose ☐ missing

Legibility: ☐ sharp, tooling evident ☐ clear, but worn ☐ partially discernable ☒ not discernable

Deterioration: ☒ broken ☐ cracked ☐ losses ☐ flaking/sugaring ☐ ferrous pins ☐ brass pins
☒ delamination/detachment ☐ spalling ☒ missing fragments ☒ other: damage initially record as early as 1904

Cost: n/c

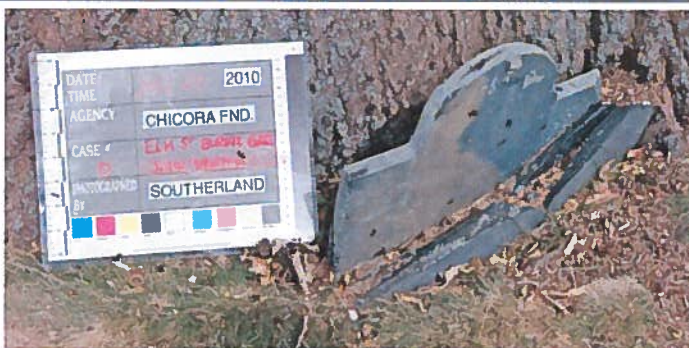
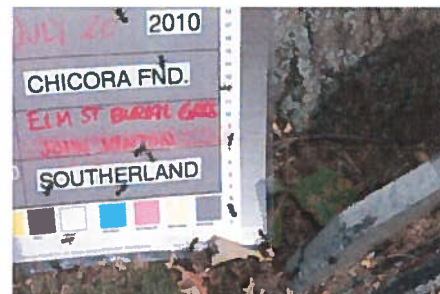
Section: D

Position: ☐ fallen ☐ tilted ☐ unstable ☐ unattached/loose ☐ missing ☒ moved behind headstone

Legibility: ☒ sharp, tooling evident ☐ clear, but worn ☐ partially discernable ☐ not discernable

Position: ☐ reset/level in ground ☐ reset/level to existing base ☐ construct new base ☐ resquare
☐ possible new base required ☐ stabilize foundation ☐ reset with NHL 3.5 1:2.5 mix ☐ reset with compound ☒ reset/level in ground ca. 5' behind headstone

Cost: \$100

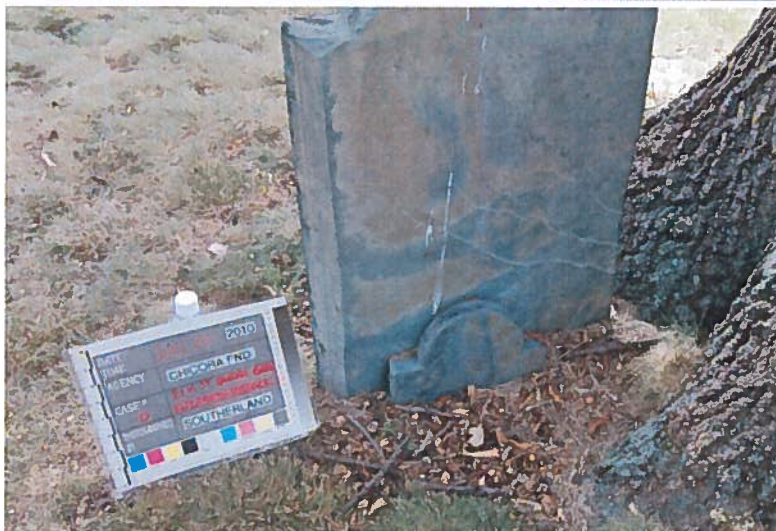
Section: E

Position: ☐ fallen ☐ tilted ☐ unstable ☒ unattached/loose ☐ missing

Legibility: ☒ sharp, tooling evident ☐ clear, but worn ☐ partially discernable ☐ not discernable

Deterioration: ☒ broken ☐ cracked ☐ losses ☐ flaking/sugaring ☐ ferrous pins ☐ brass pins
☐ delamination/detachment ☒ spalling ☐ missing fragments ☐ other:

Soiling: ☐ biological ☒ staining ☐ efflorescence ☐ other:

Position: ☒ reset/level in ground ☐ reset/level to existing base ☐ construct new base ☐ resquare
☐ possible new base required ☐ stabilize foundation ☐ reset with NHL 3.5 1:2.5 mix ☐ reset with compound

Treatment: ☐ core drill ☐ drill and pin ☒ simple adhesive repair ☒ injection grout ☐ replace bricks
☐ infill losses ☐ repoint ☐ other:

Cost: \$1200

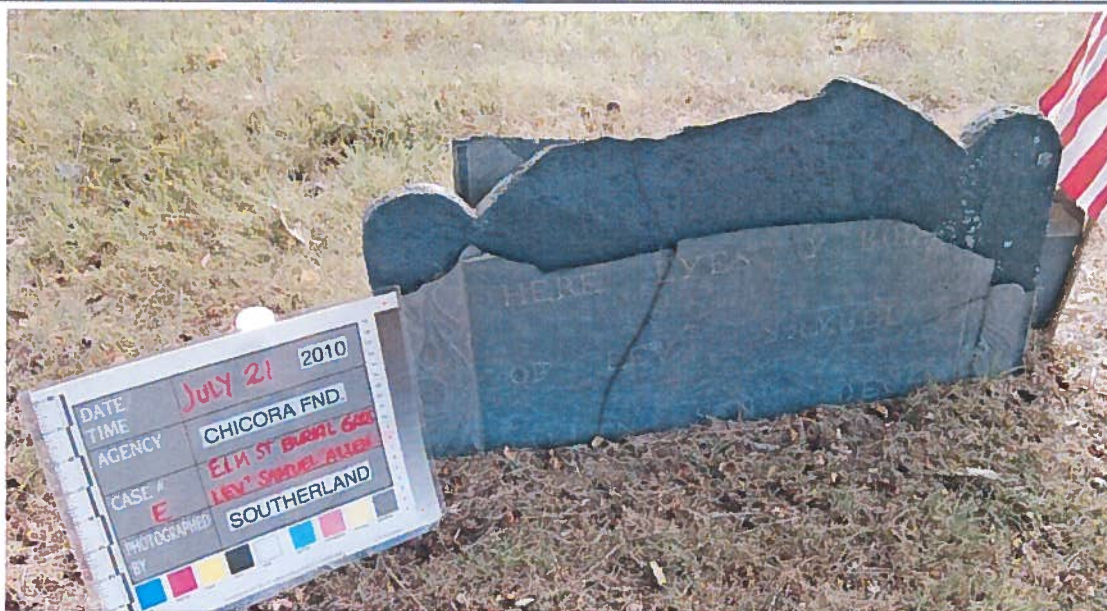
Section: E

Position: ☒ fallen ☐ tilted ☐ unstable ☐ unattached/loose ☐ missing

Deterioration: ☐ broken ☐ cracked ☐ losses ☐ flaking/sugaring ☐ ferrous pins ☐ brass pins
☐ delamination/detachment ☒ spalling ☐ missing fragments ☐ other:

Soiling: ☒ biological ☐ staining ☐ efflorescence ☐ other:

Position: ☒ reset/level in ground ☐ reset/level to existing base ☐ construct new base ☐ resquare
☐ possible new base required ☐ stabilize foundation ☐ reset with NHL 3.5 1:2.5 mix ☐ reset with compound

Treatment: ☐ core drill ☐ drill and pin ☐ simple adhesive repair ☒ injection grout ☐ replace bricks
☐ infill losses ☐ repaint ☐ other:

Cost: \$400

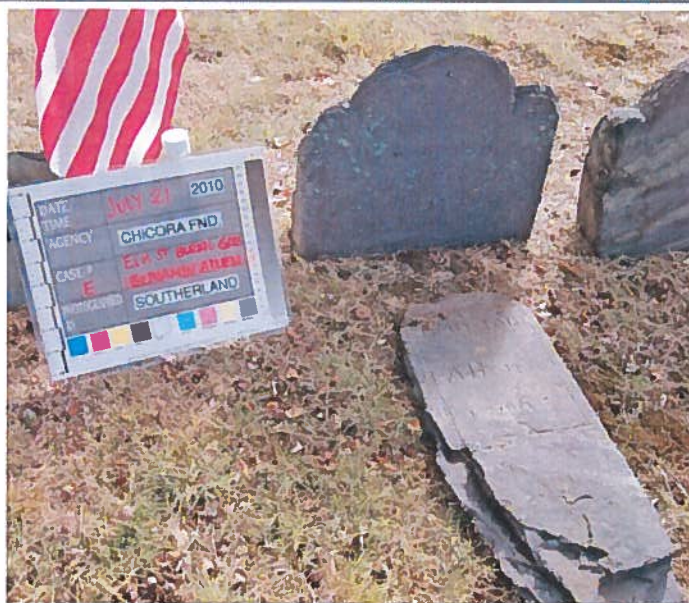
Section: E

Deterioration: ☐ broken ☒ cracked ☐ losses ☐ flaking/sugaring ☐ ferrous pins ☐ brass pins
☐ delamination/detachment ☒ spalling ☐ missing fragments ☐ other:

Soiling: ☒ biological ☐ staining ☐ efflorescence ☐ other:

Treatment: ☐ core drill ☐ drill and pin ☐ simple adhesive repair ☒ injection grout ☐ replace bricks
☒ infill losses ☐ repoint ☐ other:

Cost: \$500

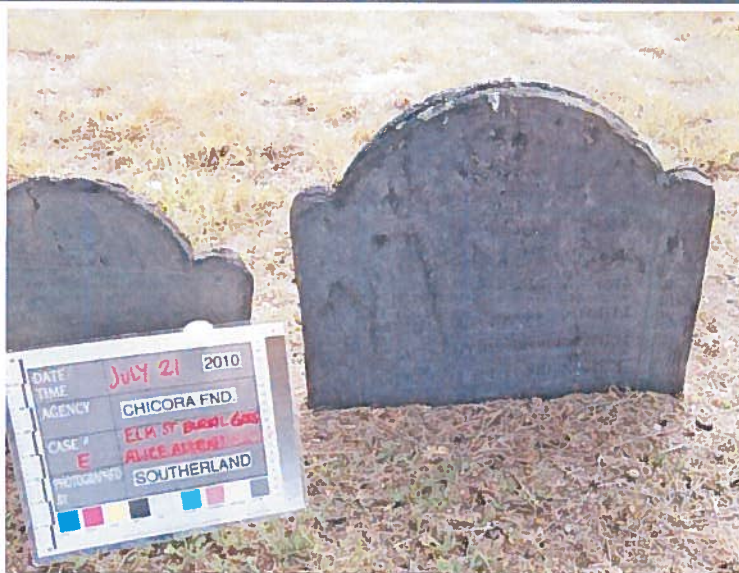
Section: E

Deterioration: ☐ broken ☒ cracked ☐ losses ☐ flaking/sugaring ☐ ferrous pins ☐ brass pins
☐ delamination/detachment ☒ spalling ☐ missing fragments ☐ other:

Soiling: ☒ biological ☐ staining ☐ efflorescence ☐ other:

Treatment: ☐ core drill ☐ drill and pin ☐ simple adhesive repair ☒ injection grout ☐ replace bricks
☐ infill losses ☐ repoint ☒ other: may require future inspections

Cost: \$500

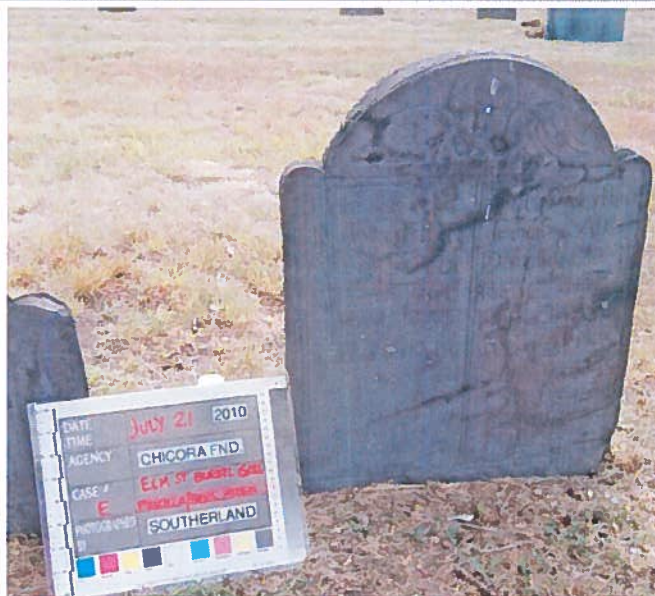
Section: E

Position: ☐ fallen ☒ tilted ☐ unstable ☐ unattached/loose ☐ missing

Deterioration: ☐ broken ☒ cracked ☐ losses ☐ flaking/sugaring ☐ ferrous pins ☐ brass pins
☐ delamination/detachment ☒ spalling ☐ missing fragments ☐ other:

Soiling: ☒ biological ☐ staining ☐ efflorescence ☐ other:

Position: ☒ reset/level in ground ☐ reset/level to existing base ☐ construct new base ☐ resquare
☐ possible new base required ☐ stabilize foundation ☐ reset with NHL 3.5 1:2.5 mix ☐ reset with compound

Treatment: ☐ core drill ☐ drill and pin ☐ simple adhesive repair ☒ injection grout ☐ replace bricks
☒ infill losses ☐ repoint ☐ other:

Cost: \$700

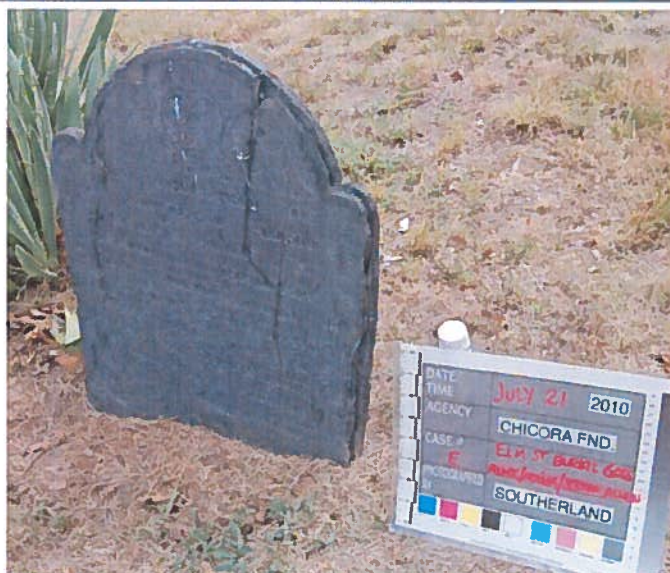
Section: E

Position: ☒ fallen ☐ tilted ☐ unstable ☐ unattached/loose ☐ missing

Legibility: ☐ sharp, tooling evident ☐ clear, but worn ☒ partially discernable ☐ not discernable

Deterioration: ☒ broken ☐ cracked ☐ losses ☐ flaking/sugaring ☐ ferrous pins ☐ brass pins
☐ delamination/detachment ☐ spalling ☐ missing fragments ☒ other: mower damage

Soiling: ☒ biological ☐ staining ☐ efflorescence ☐ other:

Position: ☐ reset/level in ground ☐ reset/level to existing base ☐ construct new base ☐ resquare
☒ possible new base required ☐ stabilize foundation ☐ reset with NHL 3.5 1:2.5 mix ☐ reset with compound

Treatment: ☐ core drill ☒ drill and pin ☐ simple adhesive repair ☐ injection grout ☐ replace bricks
☒ infill losses ☐ repoint ☒ other: consolidate with HCT

Cost: \$1000

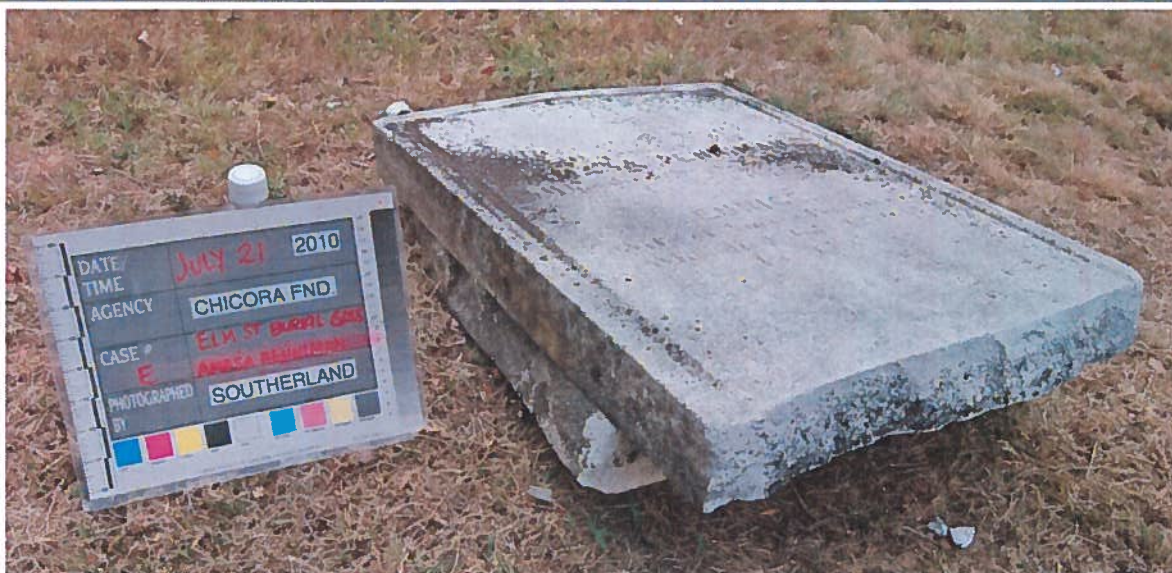
Section: E

Deterioration: ☐ broken ☒ cracked ☐ losses ☐ flaking/sugaring ☐ ferrous pins ☐ brass pins
☐ delamination/detachment ☒ spalling ☐ missing fragments ☐ other:

Soiling: ☒ biological ☐ staining ☐ efflorescence ☐ other:

Cost: \$400

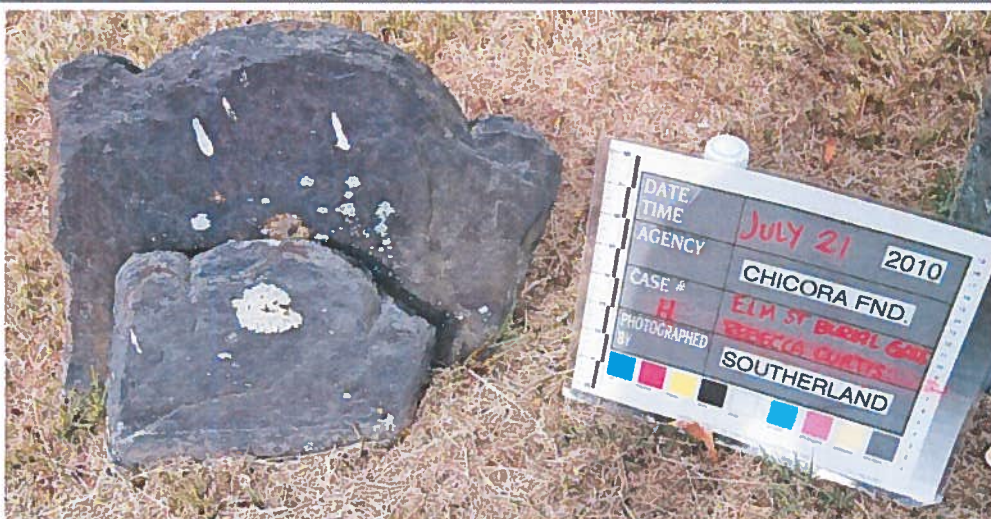
Section: H

Position: ☐ fallen ☐ tilted ☐ unstable ☐ unattached/loose ☐ missing ☒ moved behind headstone

Legibility: ☒ sharp, tooling evident ☐ clear, but worn ☐ partially discernable ☐ not discernable

Position: ☐ reset/level in ground ☐ reset/level to existing base ☐ construct new base ☐ resquare
☐ possible new base required ☐ stabilize foundation ☐ reset with NHL 3.5 1:2.5 mix ☐ reset with
compound ☒ reset/level in ground ca. 5' behind headstone

Cost: \$100
